Inspection Photos

I00090053+07231

Location 10 KM E SUPERIOR Stucture Name: none

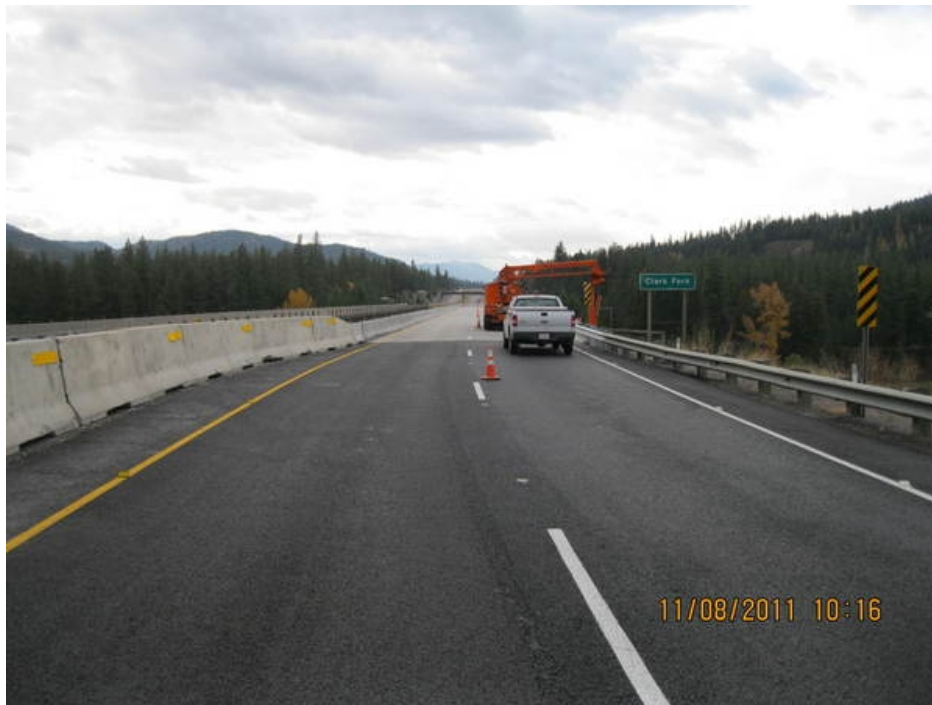
AOL **Notes**

Looking AOL. Flow From left to right.

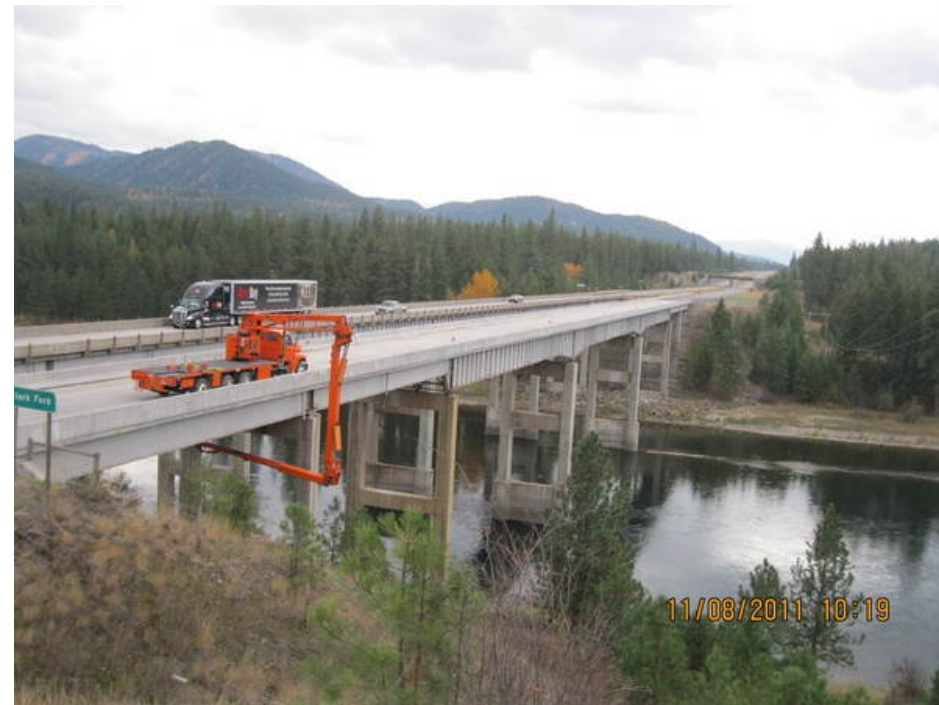
Profile **Notes**

Profile right side. Looking AOL. Flow from LT to RT.

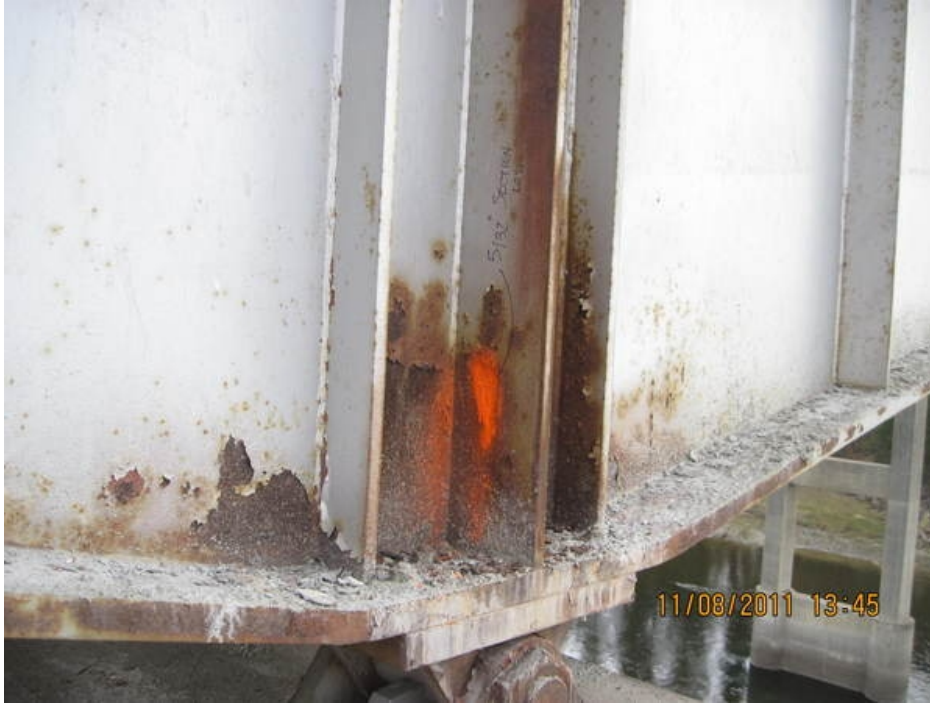
Bent 4 Right Girder

Bent 4 right ext girder 5/32" section loss on Bearing stiffener span 3 side. Span 4 side has 3/32" section loss same general area. Bearing stiffener 1" thick. See next photo.

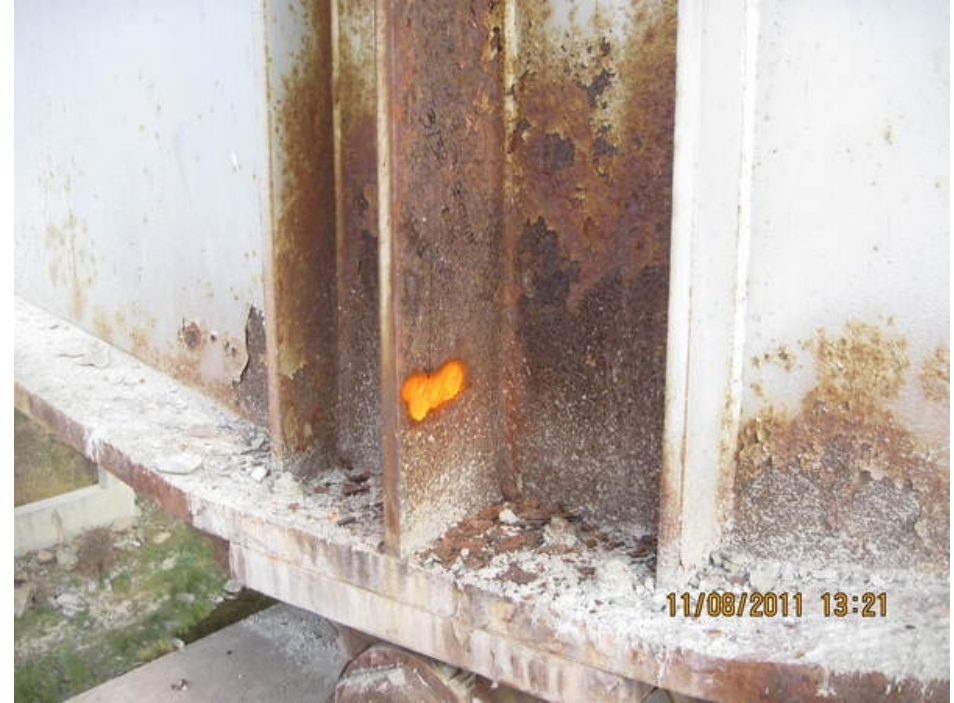
Bent 4 Right girder

Bent 4 span 4 side bearing stiffener 3/32" section loss. Span 3 side has 5/32" in same general area, see previous photo. Bearing stiffener is 1" thick.

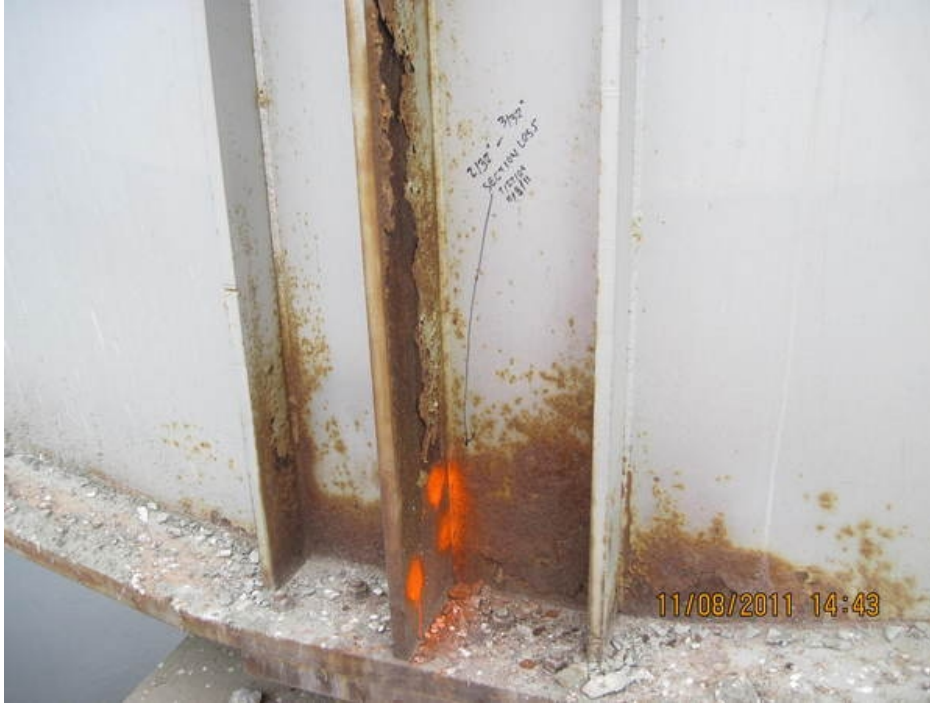
Bent 5 right girder

Bent 5 right side girder. Bearing stiffener 2/32"-3/32" section loss no change from 2009.

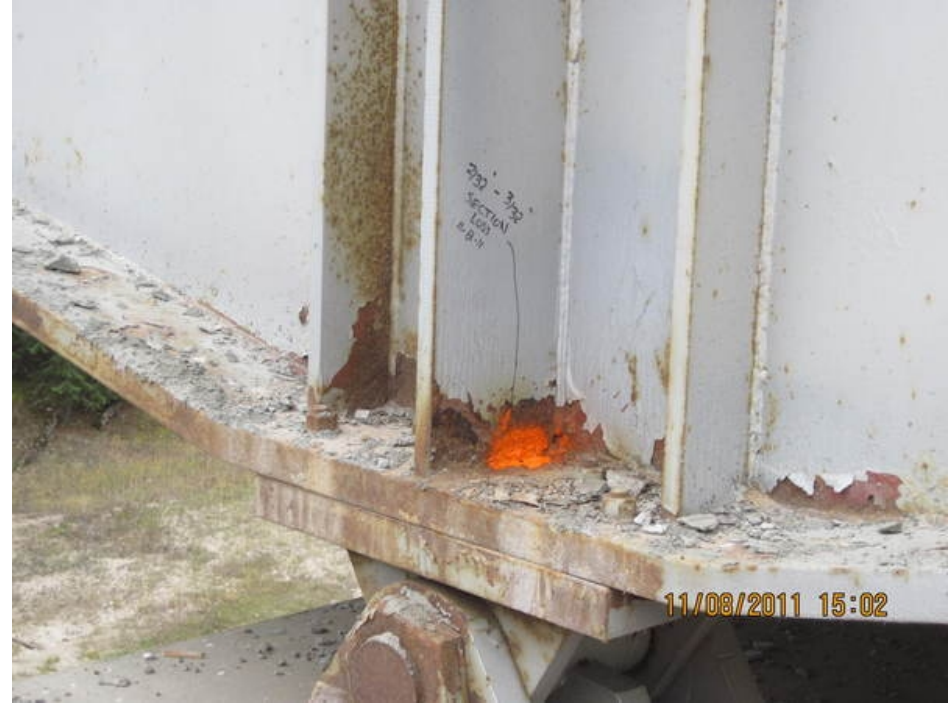
Bent 5 left girder

Bent 5 left girder, bearing stiffener 2/32"-3/32" section loss.

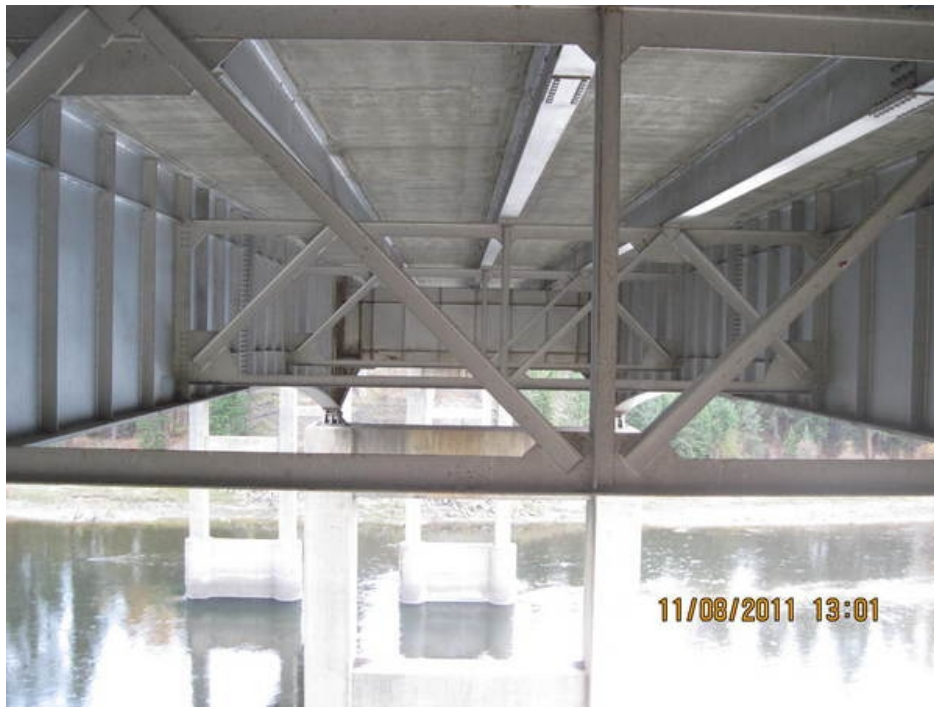
Under deck span3 AOL

Under deck view span 3 AOL.

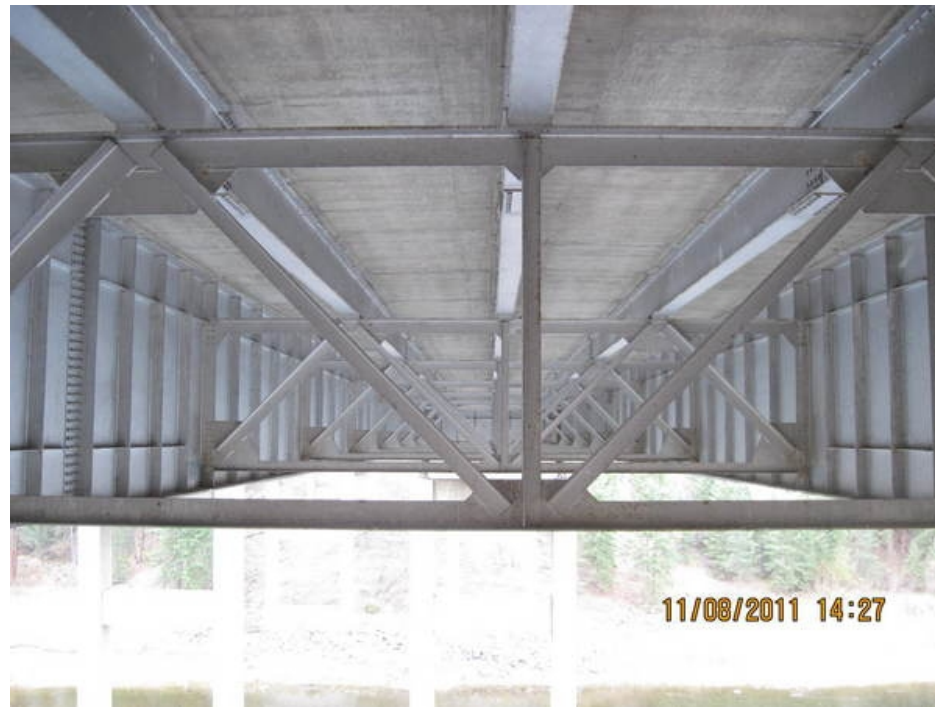
Under deck span4 bol

Under deck view span 4 looking BOL.

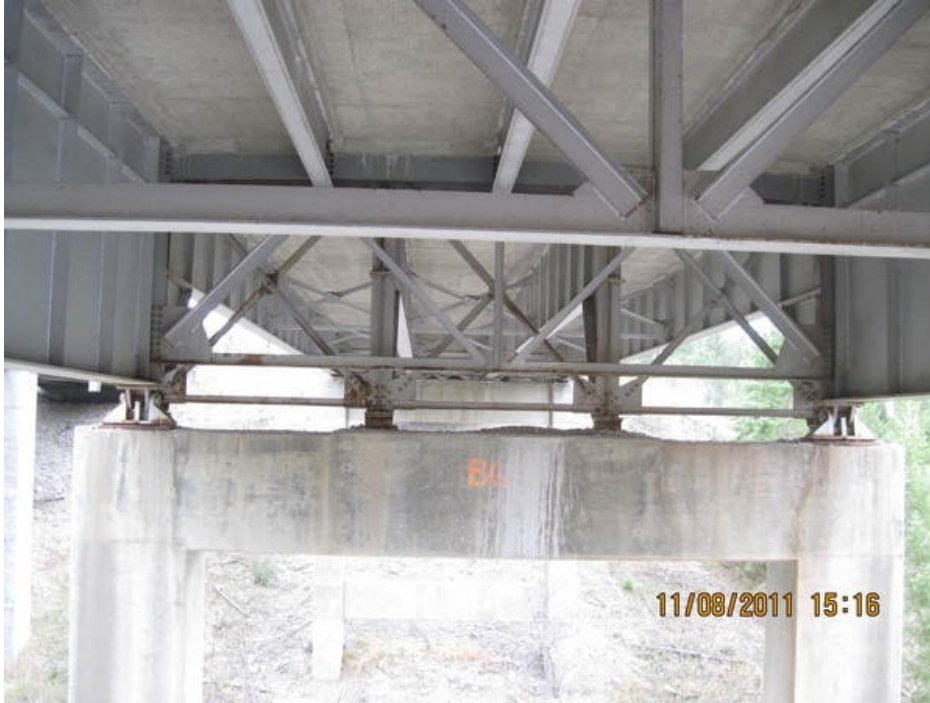
Under deck span5 AOL

Under deck view span 5 AOL.

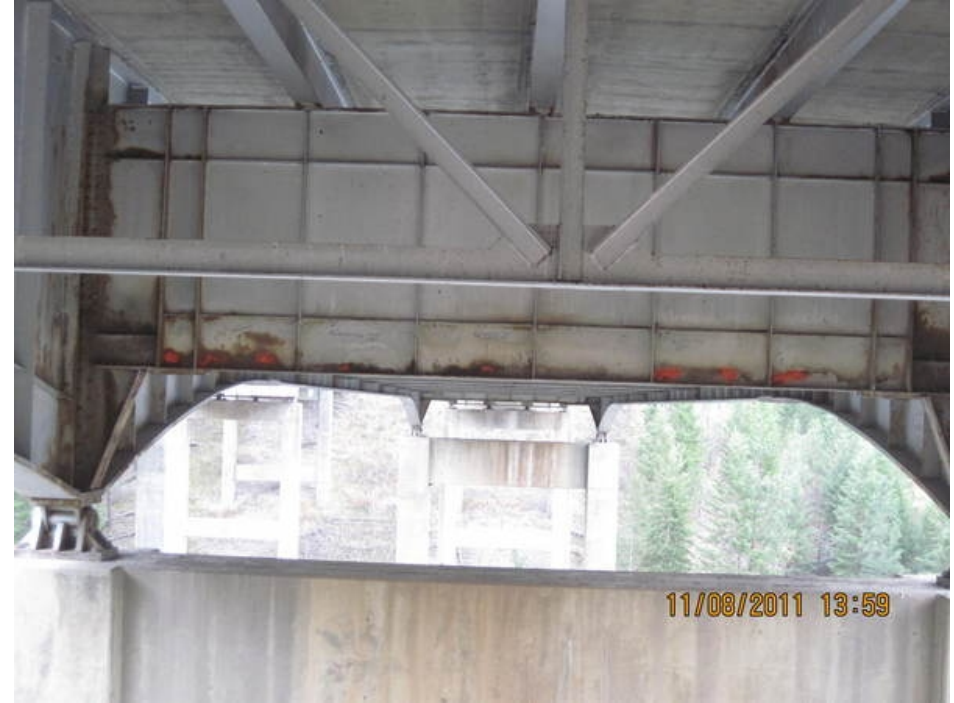
Bent 4 floor beam looking aol. Note section loss on web near bottom flange. No increase of section loss in these areas this inspection. web is 10/32" thick.

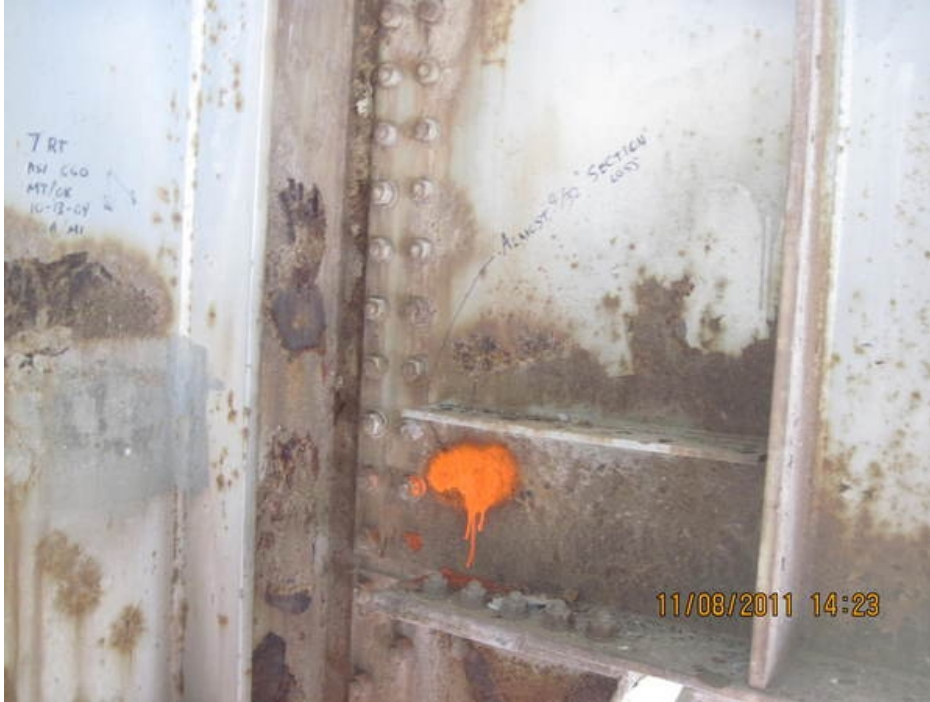
Bent 4 floor beam span 4 side, right side. 4/32" section loss in web near bottom flange. Web is 10/32" thick.

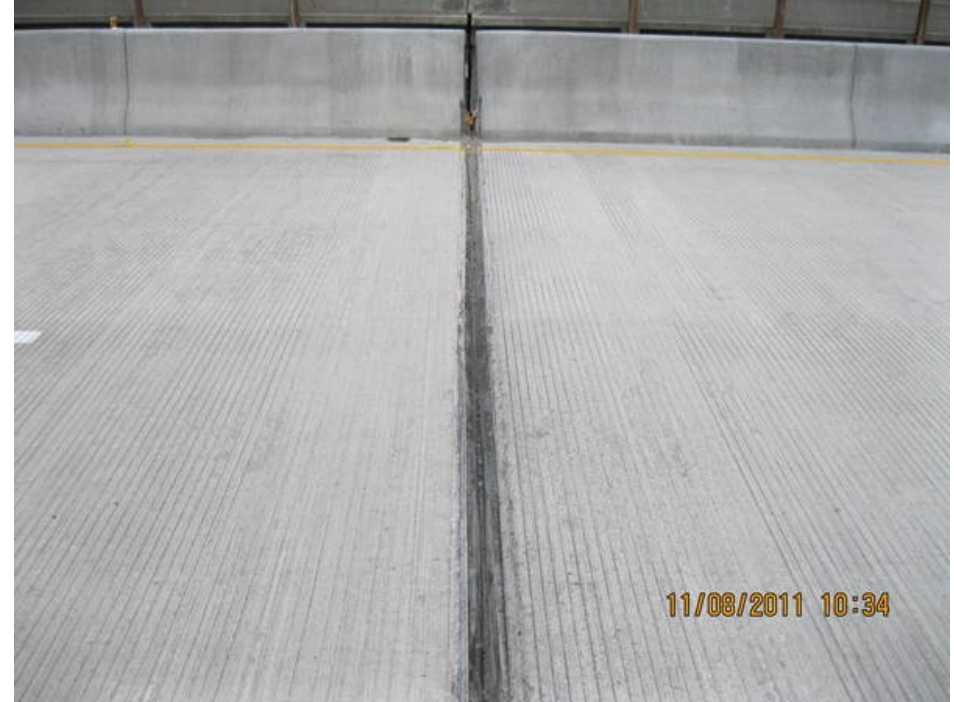
Joint bent 6

New Strip seal joint 2011. Bent 2, 3, 7, similar.

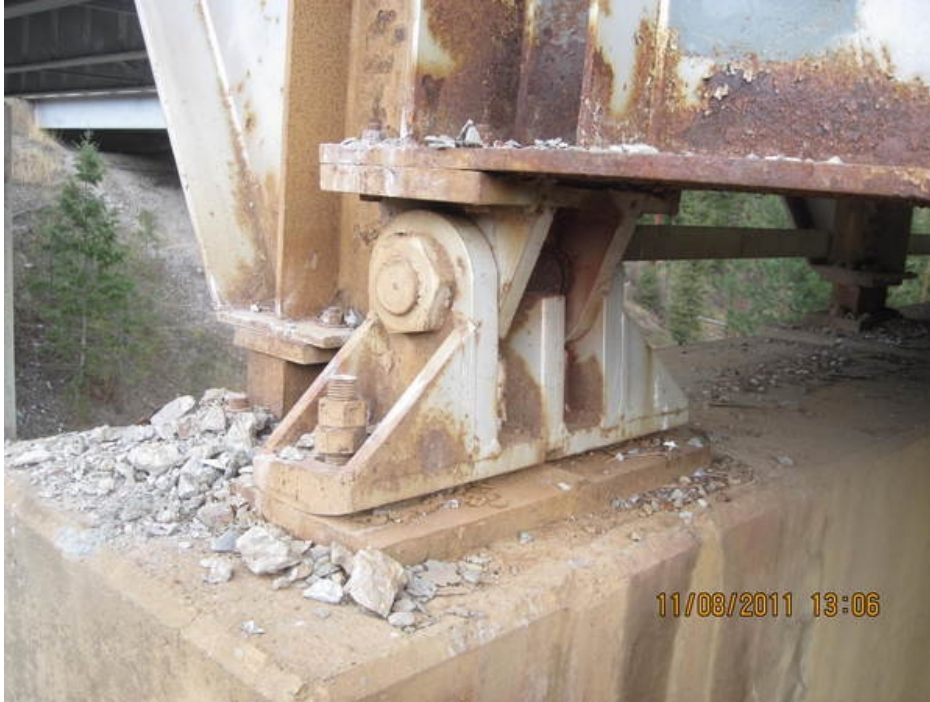
Bent 3 right bearing

Bent 3 span 3 right bearing. Left bearing similar.

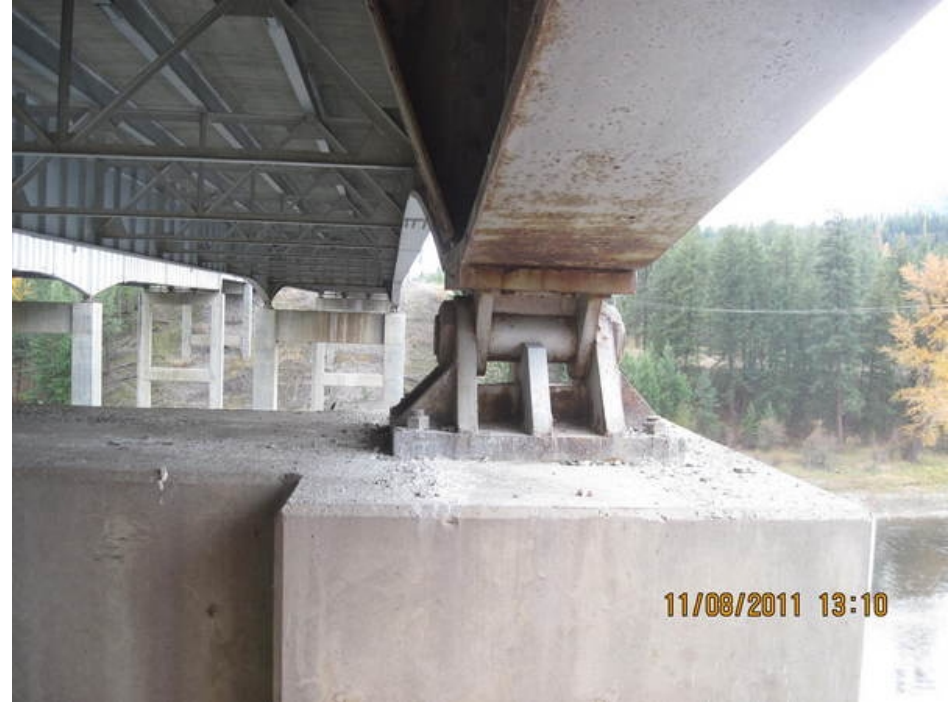
Bent 4 right bearing

Bent 4 right side bearing looking AOL. Left bearing similar.

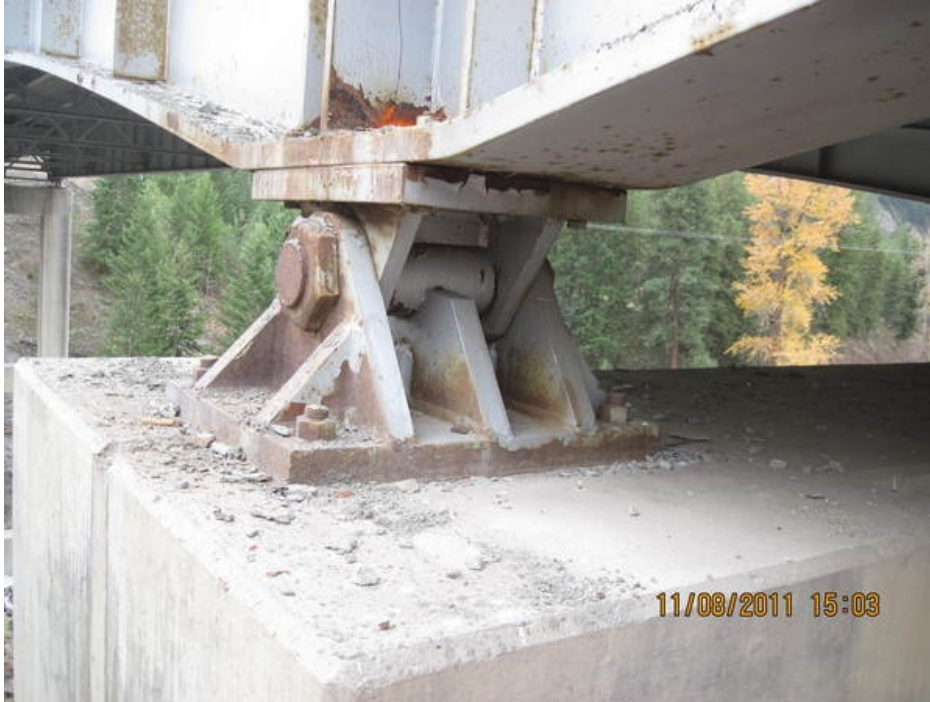
Bent 5 left bearing

Bent 5 left side bearing looking AOL. Right bearing similar.

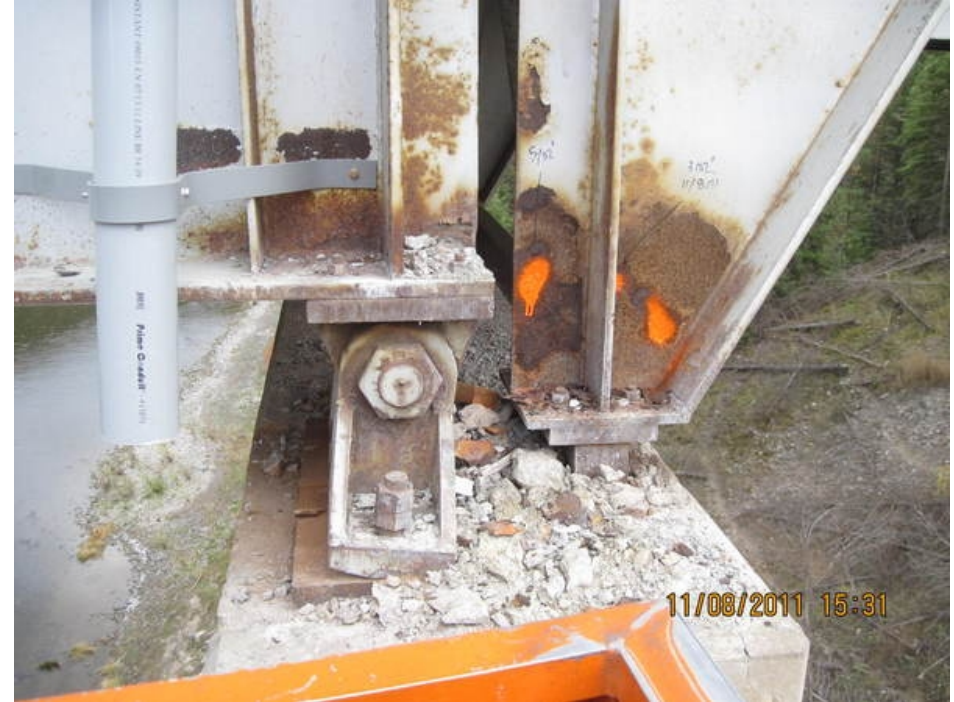
Bent 6 right bearing

Bent 6 right side bearing span 5 side (left side of photo). Left side bearing similar.
Note: concrete rubble, areas of section loss on knee brace of girder, span 6 side.

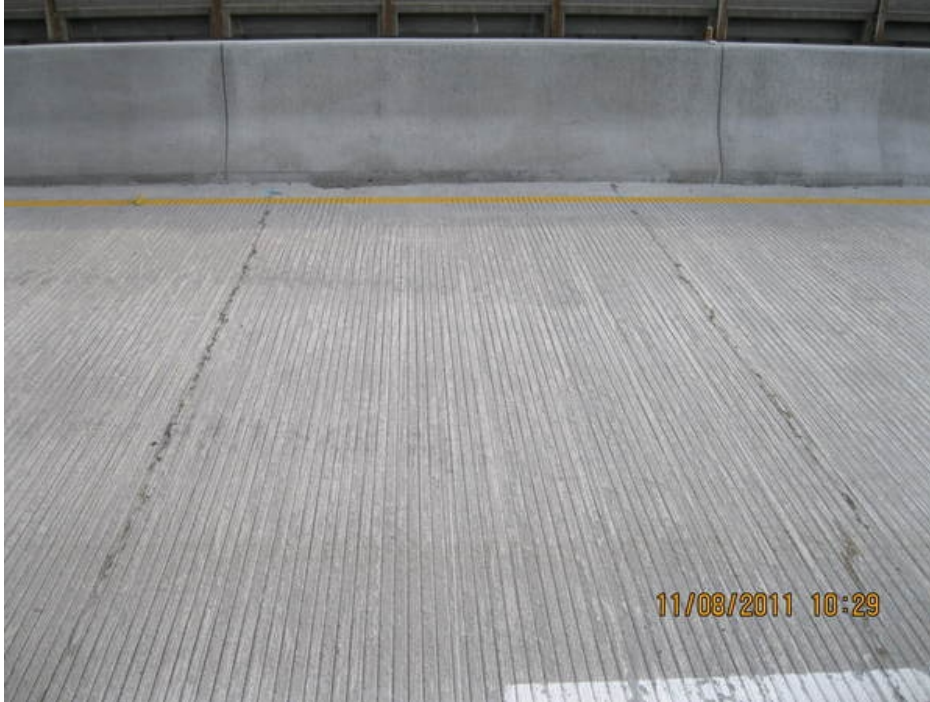
Deck **Notes**

New concrete deck with epoxy coated rebar 2011. Minor deck cracking, cracking was sealed under construction 2011. Note new concrete barrier rail.

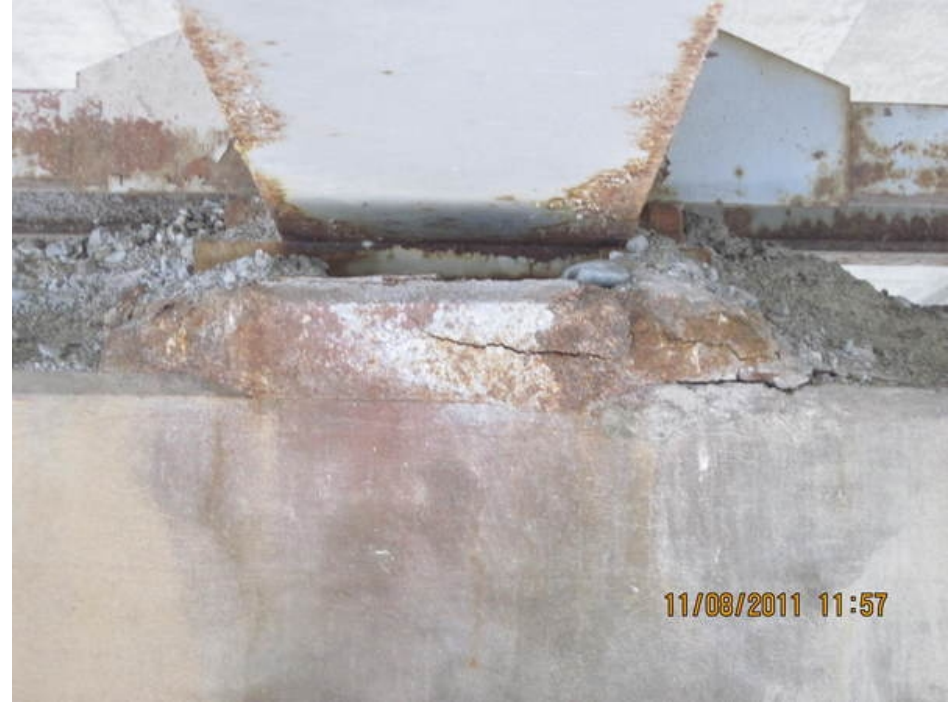
Bent 2 bearing pad **Notes**

Bent 2 span 2 bearing pad second from the left. Same location photo taken 2009 inspection. Bearing pads throughout continue to deteriorate.

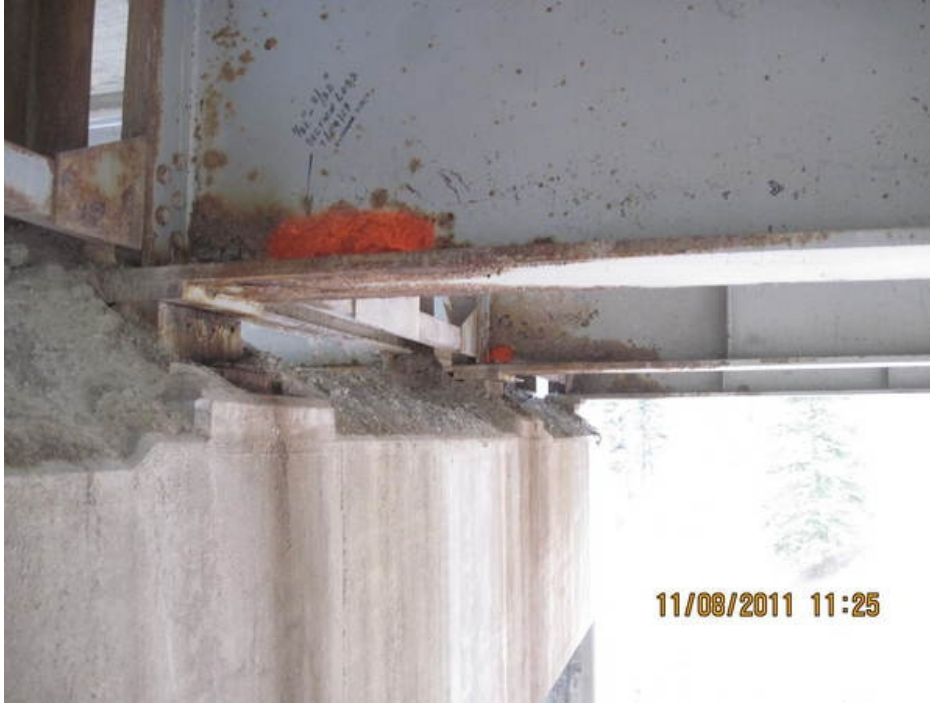
Bearings bent 2

Bent 2 span 1 bearings 2 through 4. Note material accumulations, Areas of section loss on girders, these areas had no change in section loss from 2009 inspection.

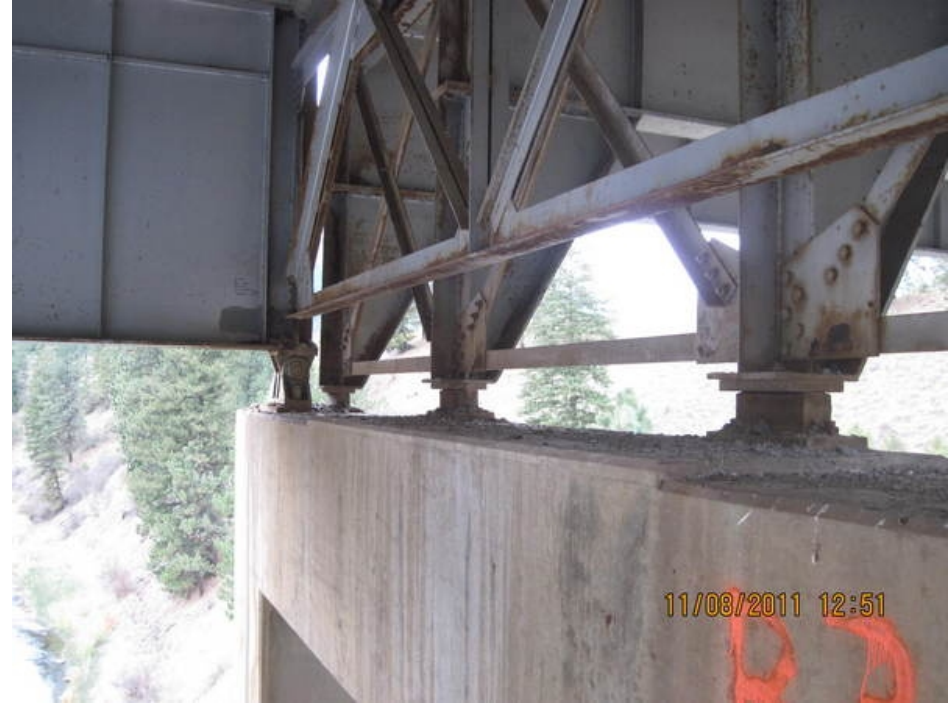
Bearing bent 3

Bearings bent 3 span 2 bearing numbers 2 through 4.

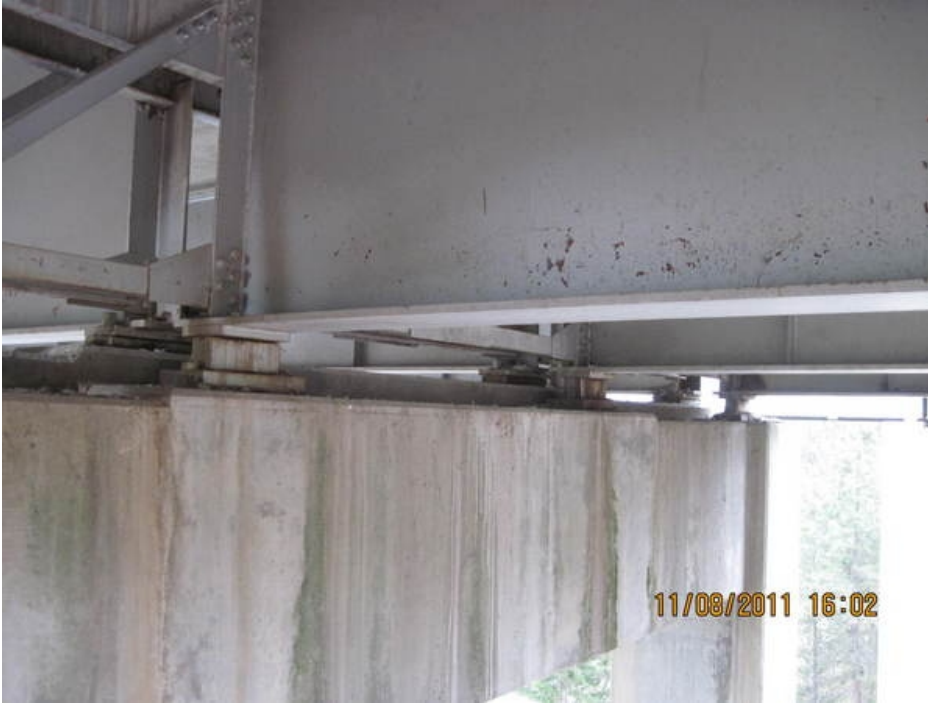
Bent 7 bearings

Bearings bent 7 spans 6 and 7. bearings 1 through 3.

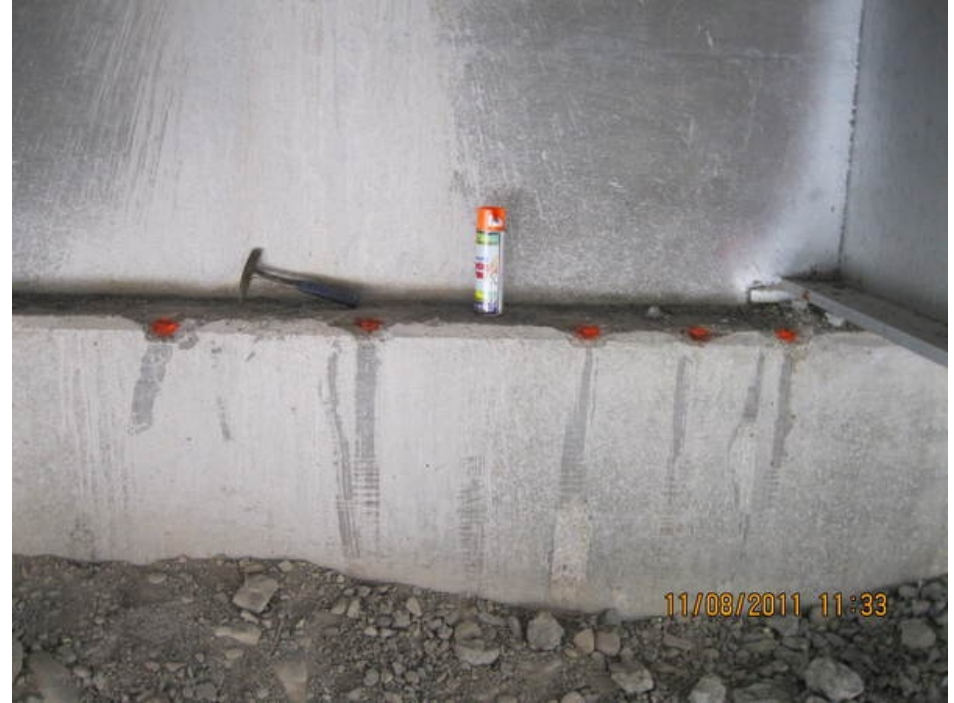
Abutment bent 1

Abutment at bent 1, cap spalls looking Bol.

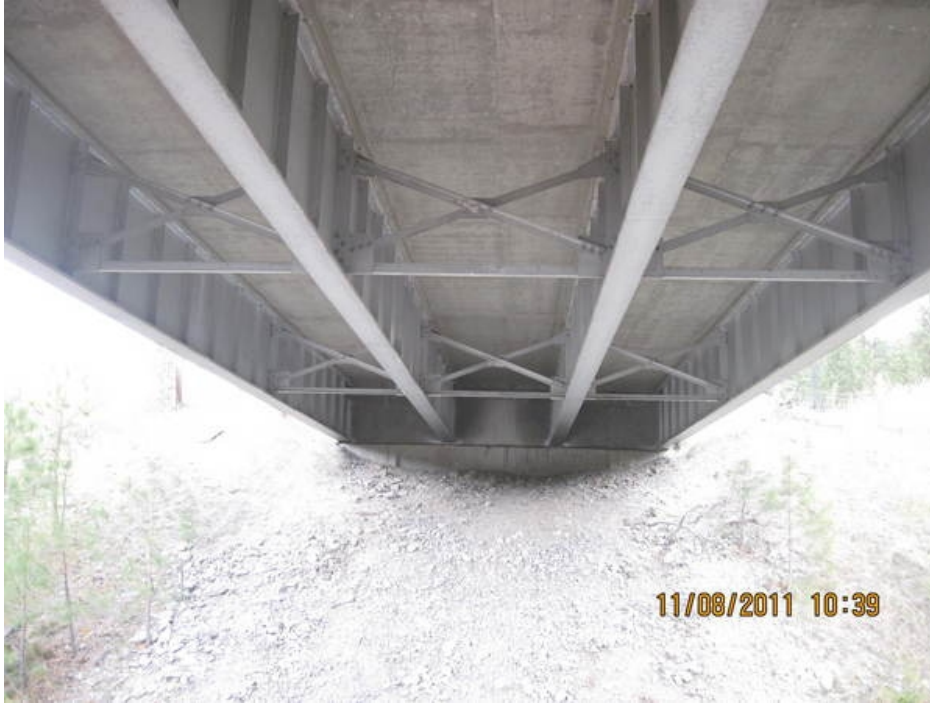
Under deck SPAN 1

Under deck span 1 looking BOL.

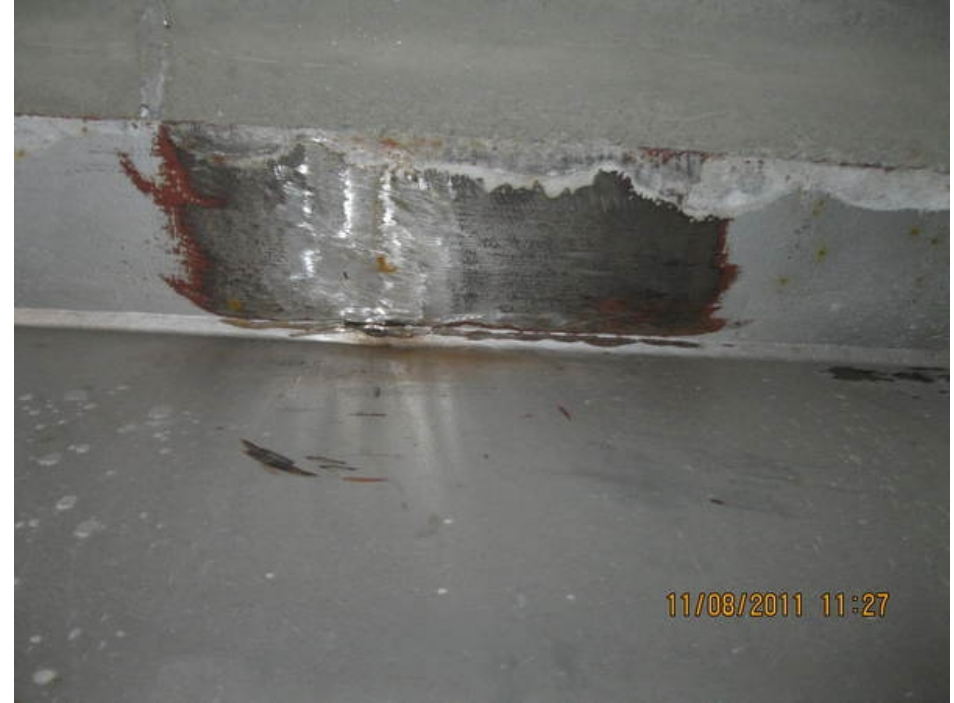
Girder span 1

Third girder from the left, bottom of top flange, repaired saw cut from 2011 reconstruction. 12 - feet aol from bent 1. One foot long by four inches wide -.
